Issues with the Most Recent Shipment from WSU → Yale
Arrived 3-Jan-2018
5 GEM4

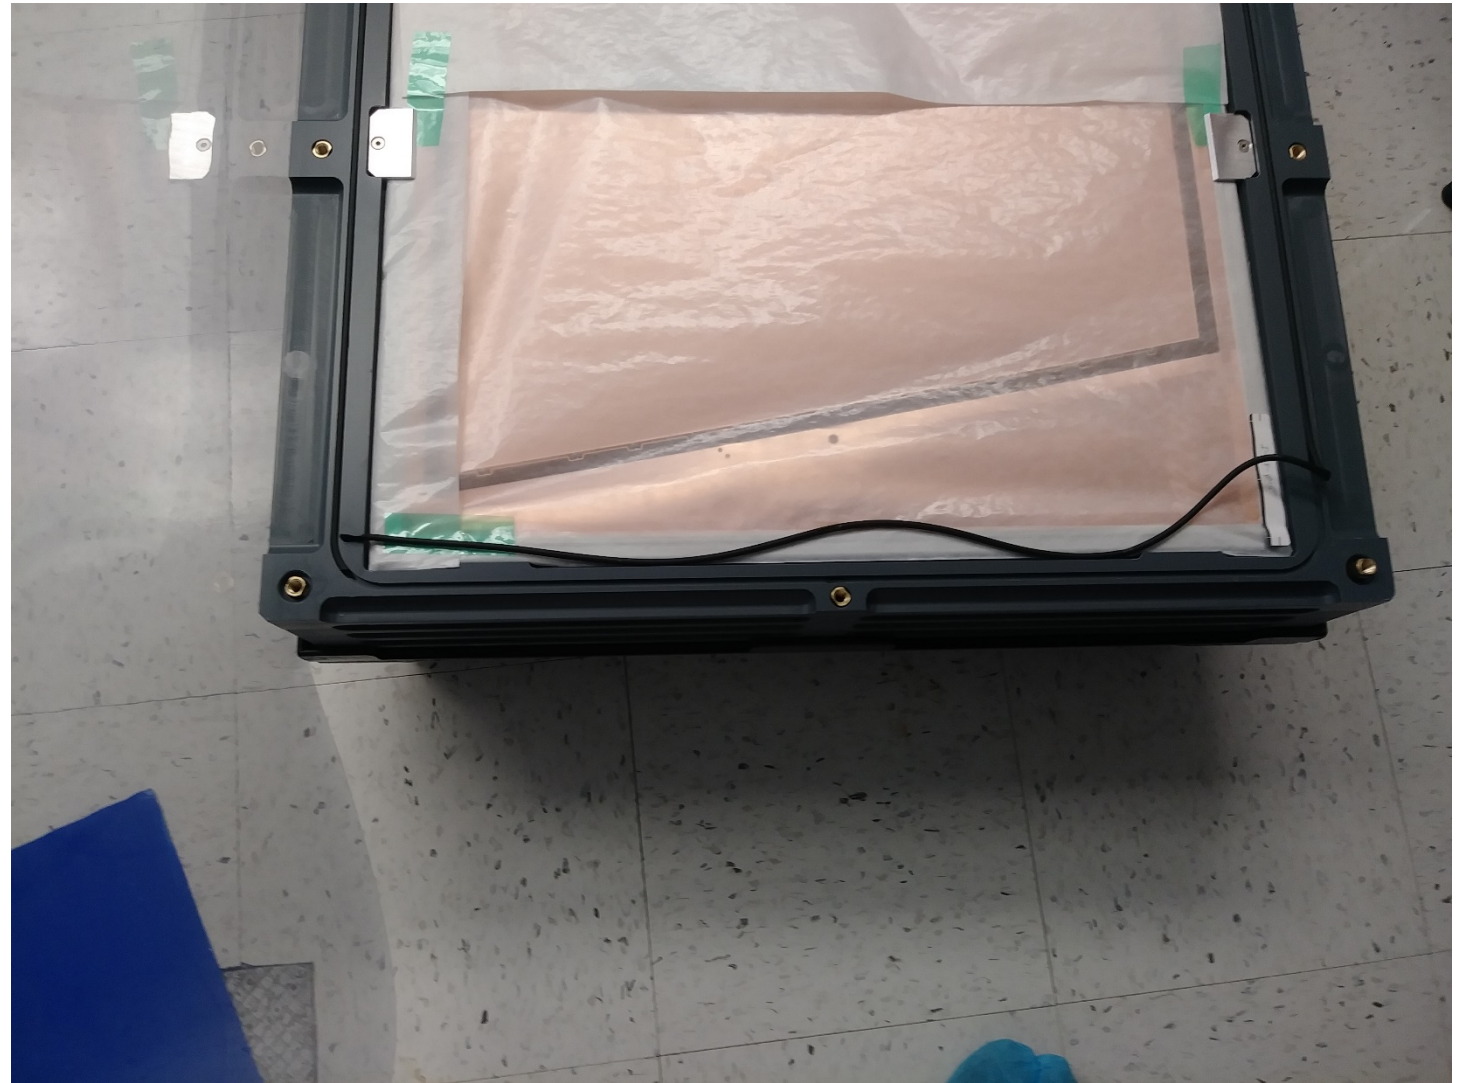
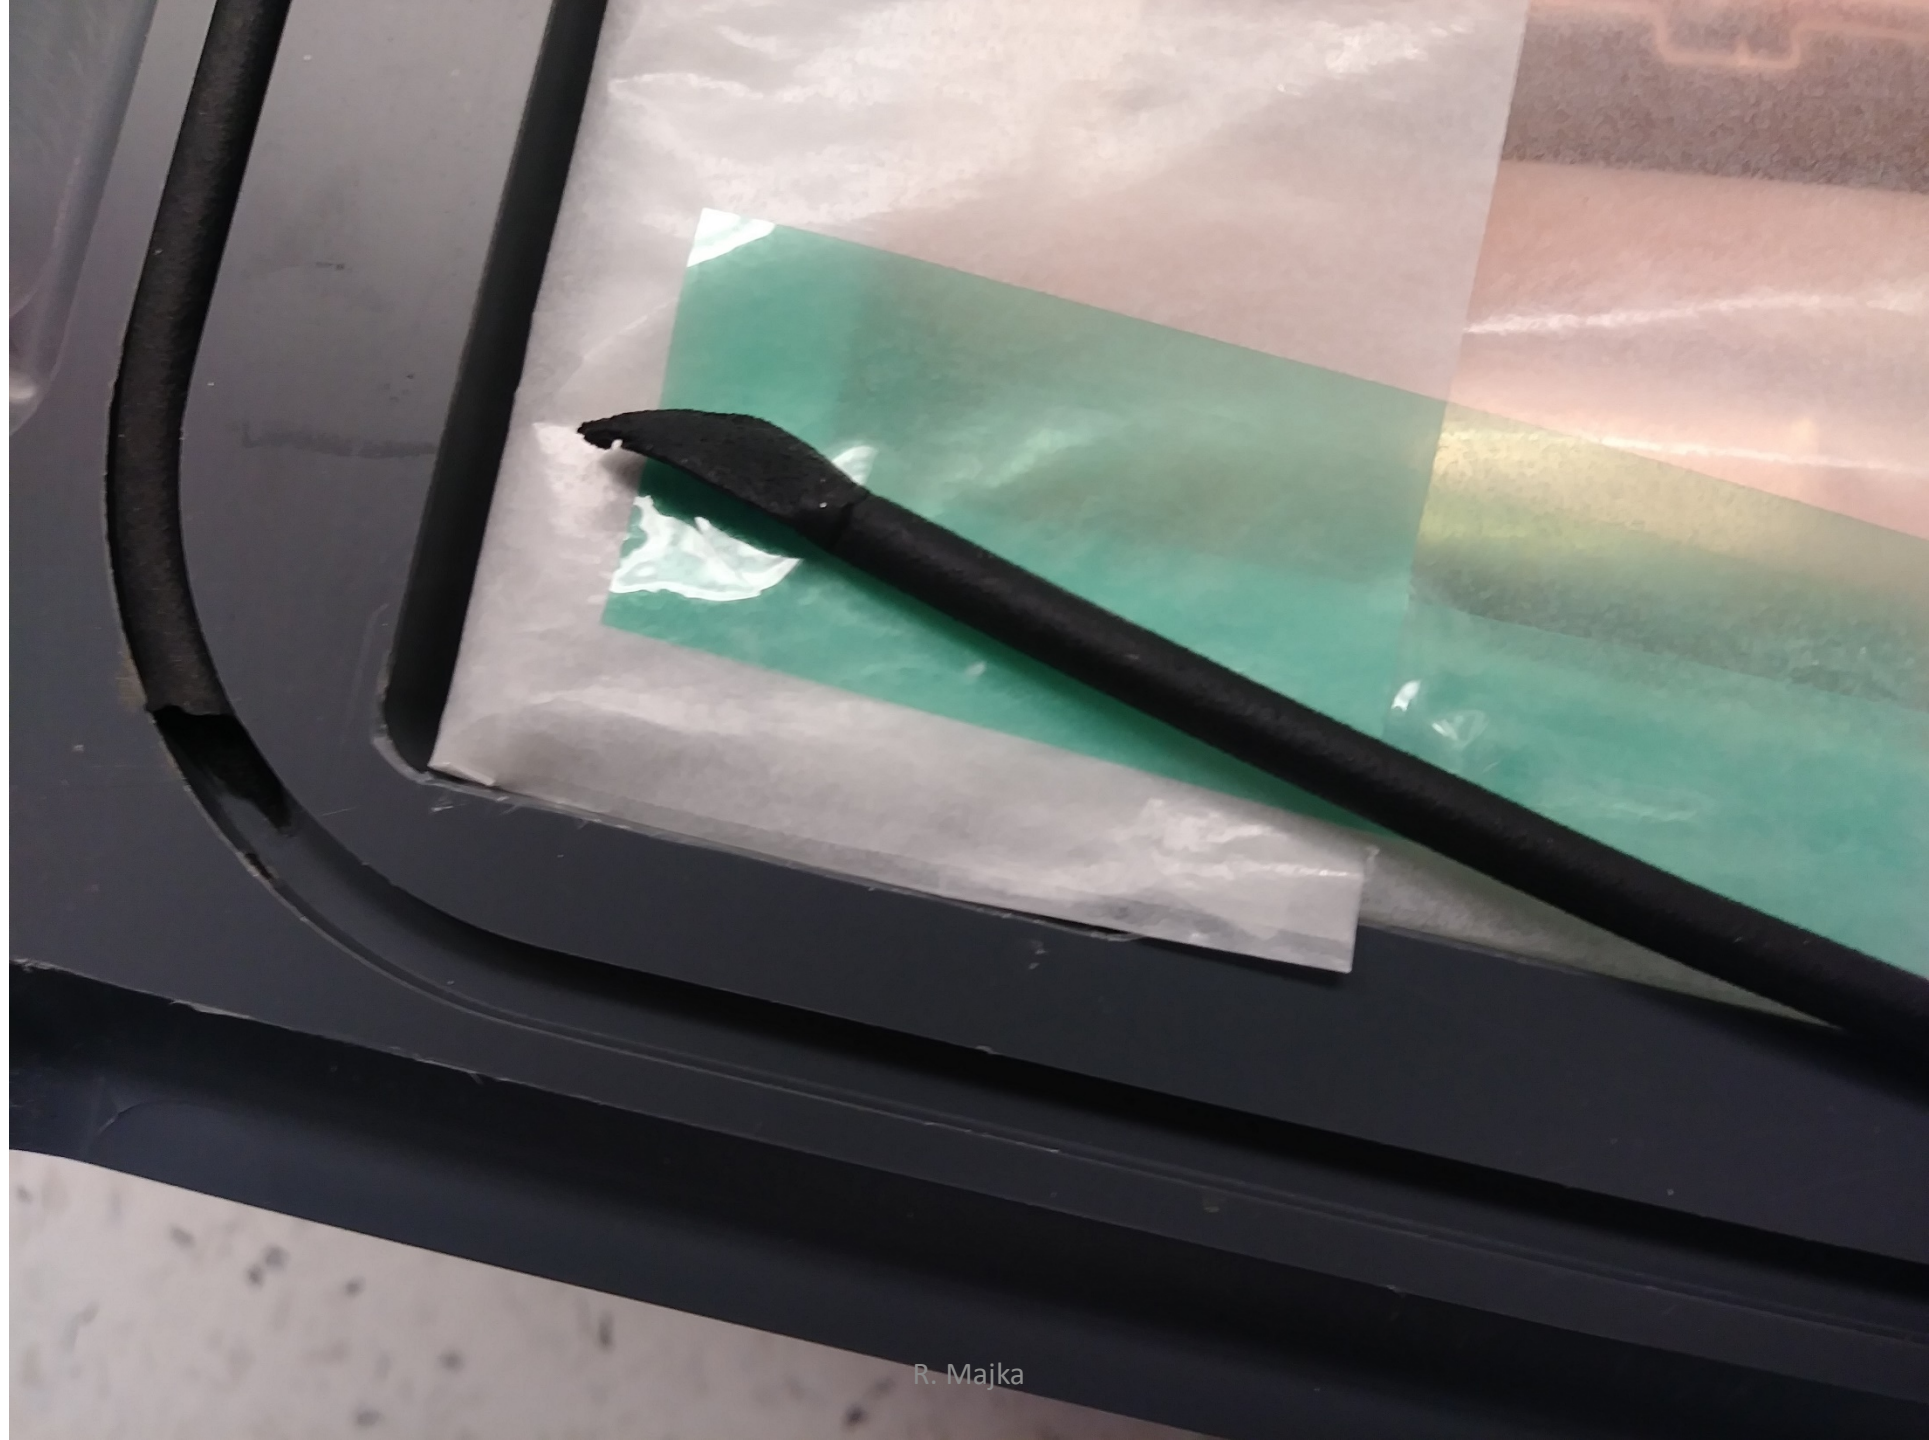
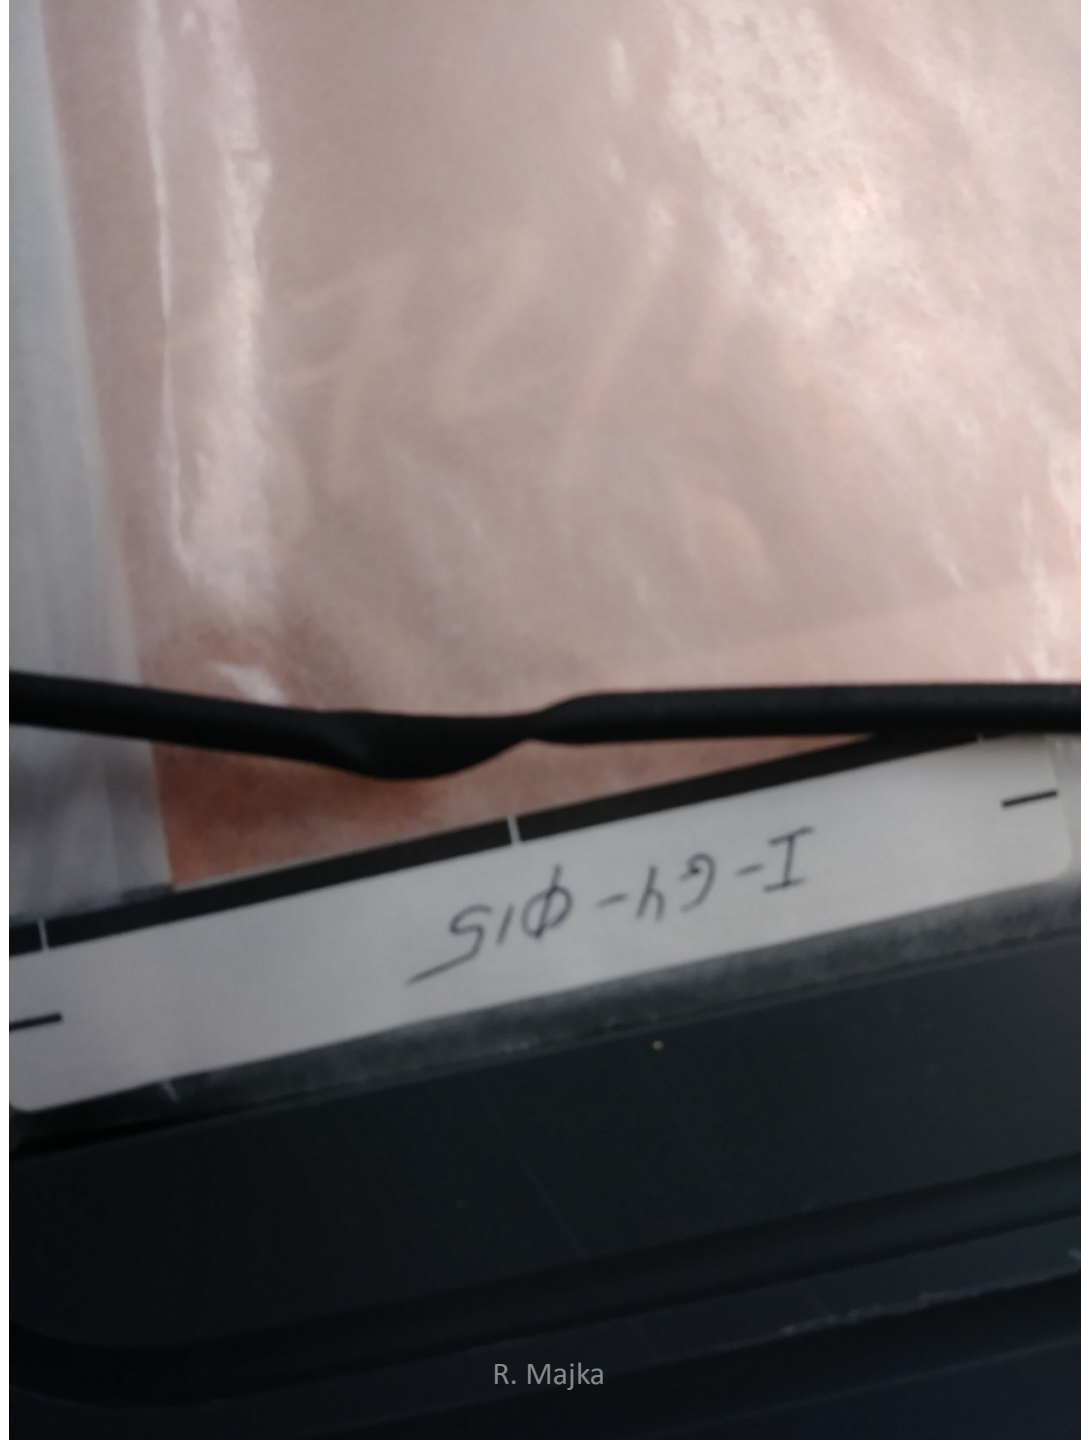
O-ring under GTS cover was not in groove at one end, broken and crushed in two places.
Fortunately contents were still clean.

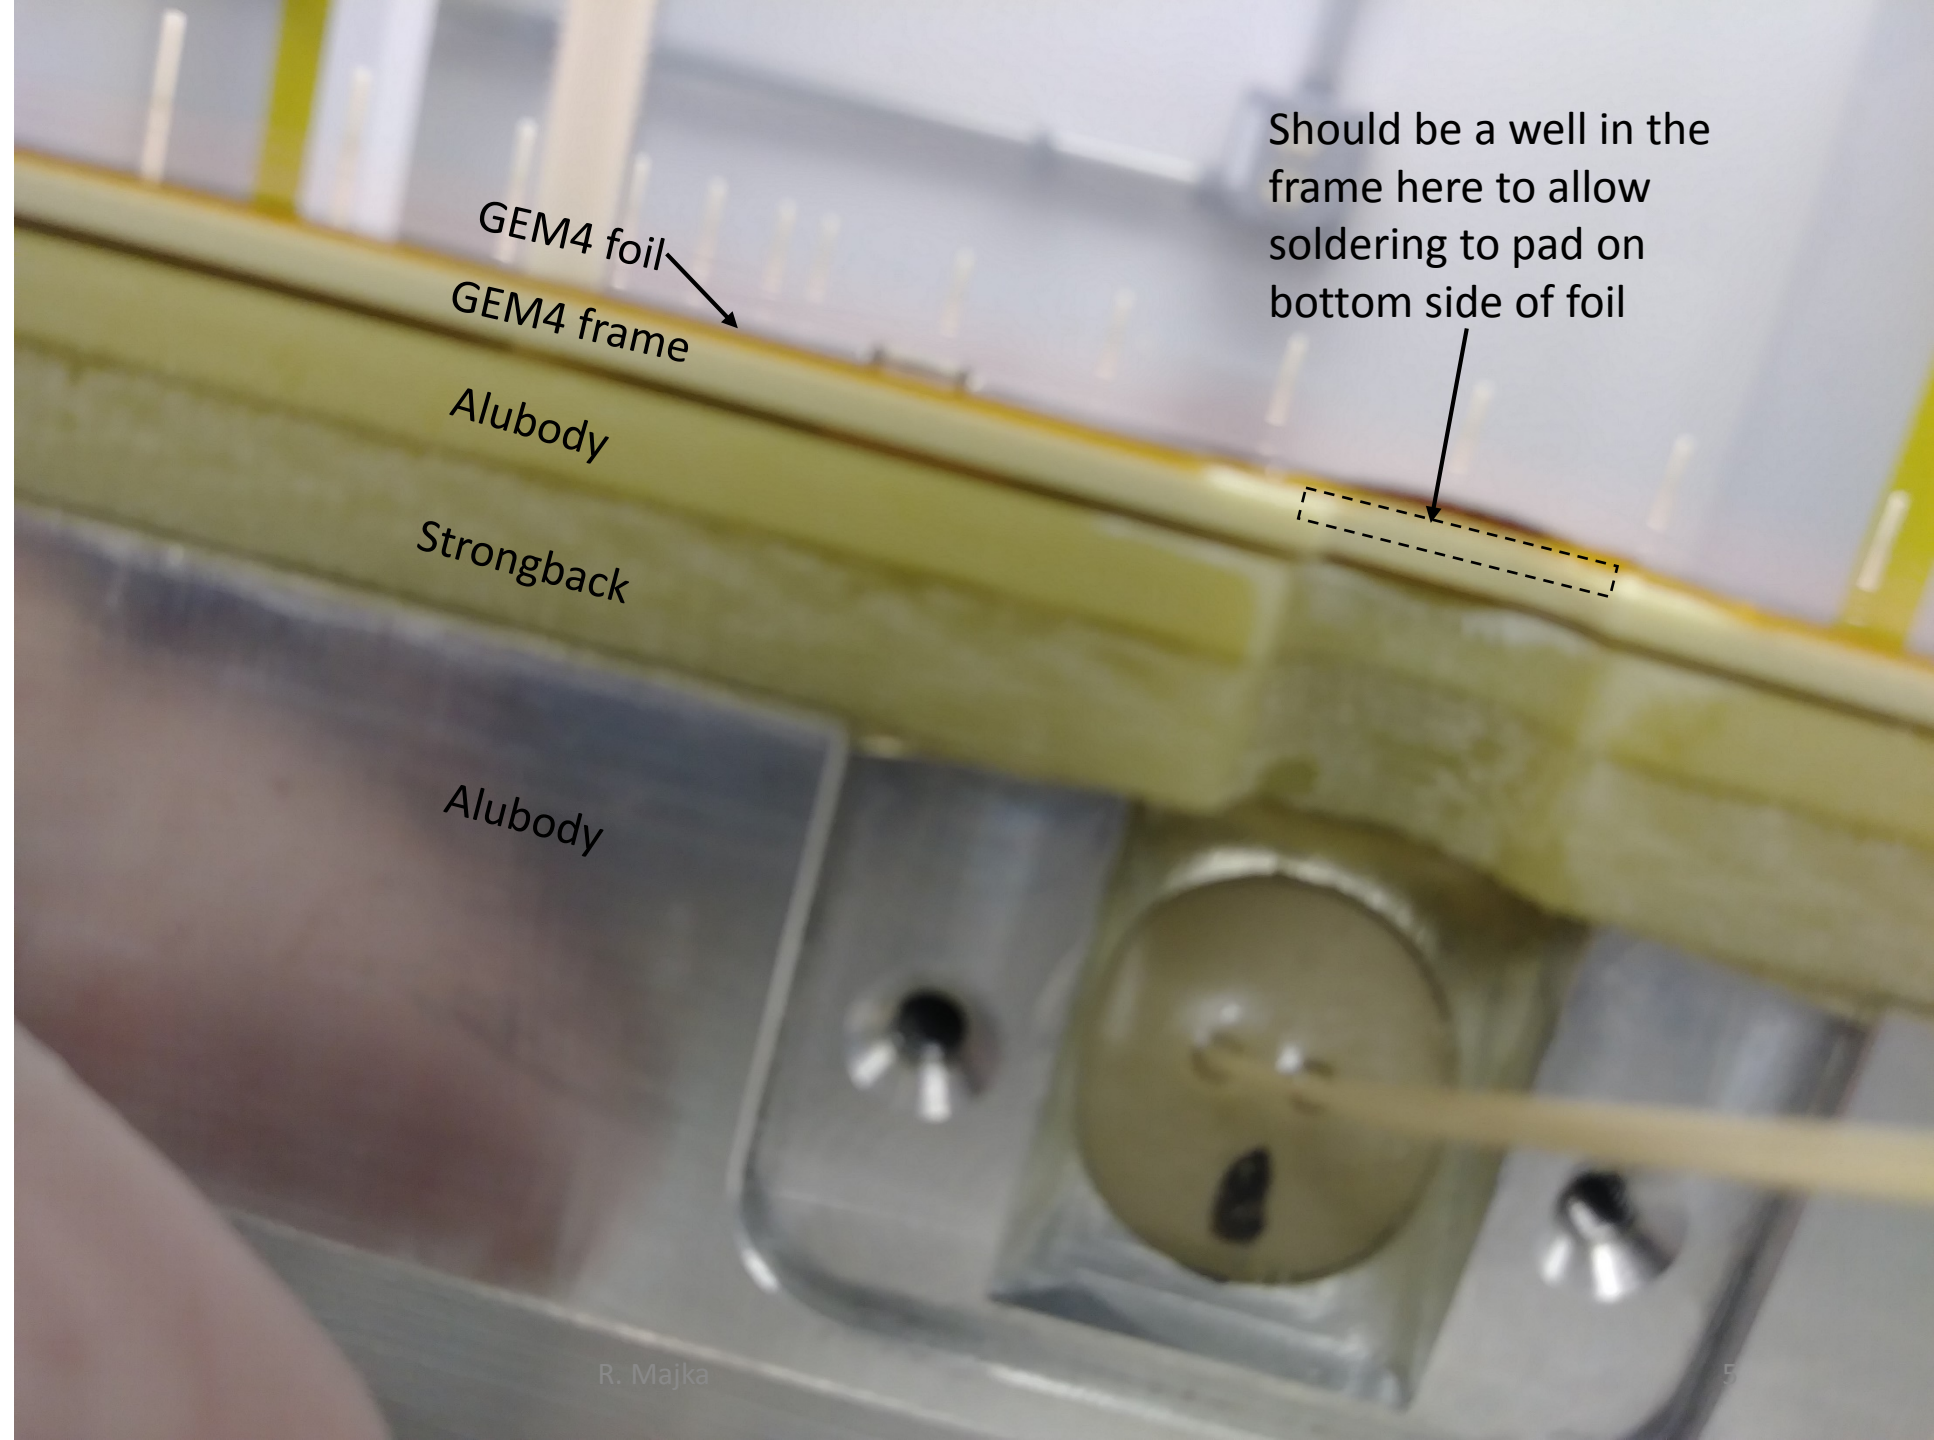
I-G4-019 – frame not machined properly. The wells for soldering to the bottom HV pads are missing.

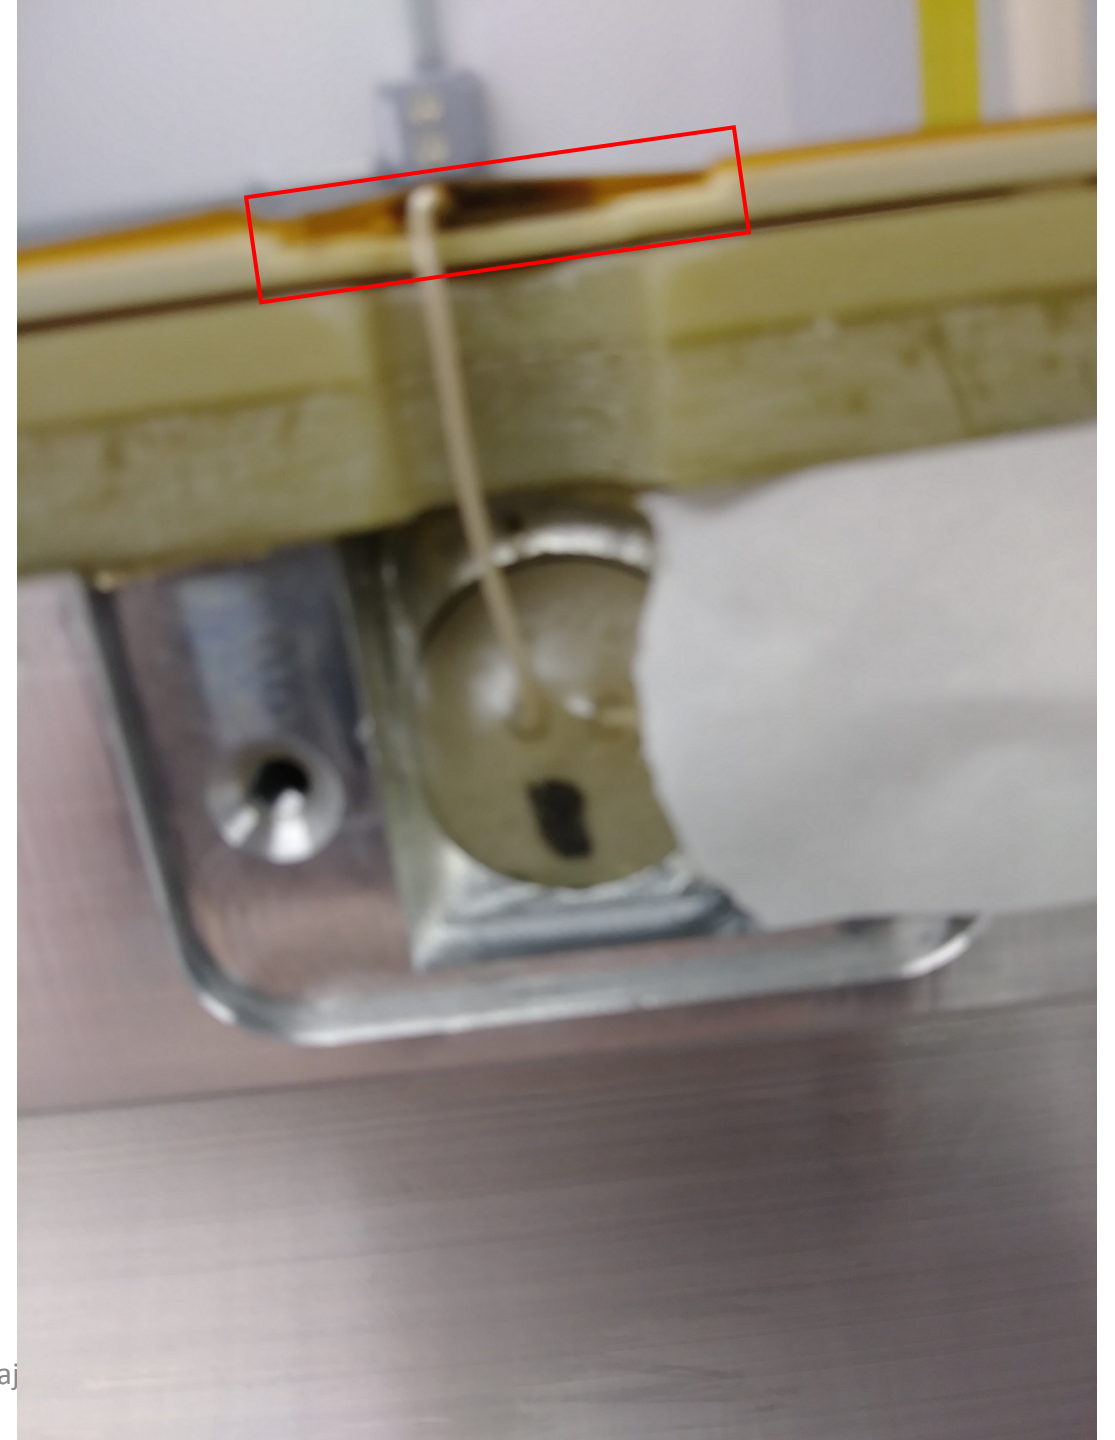
I-G4-020 – frame us machined properly.
The wells for soldering to the bottom HV
pads are present.
